Smoke and Dye Testing Summary

High Level Sewershed

Run Summary

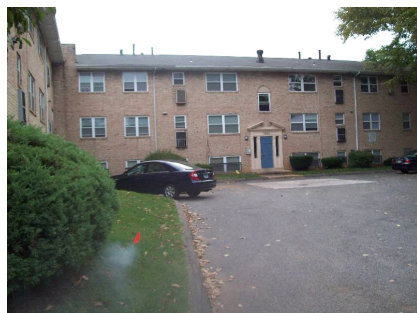
Picture \S1028-069-OB01-P01.jpg

Comments Smoke from cleanout in front yard. 3801 Wabash Ave

Comments Front of apartment complex, 3801 Wabash Ave

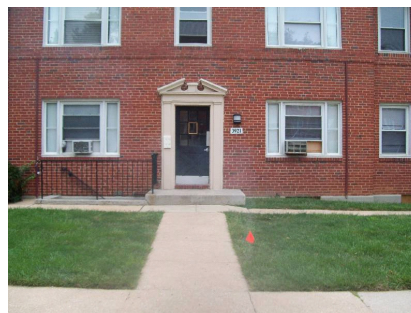
Picture \S1028-069-OB02-P01.jpg

Comments Smoke from cleanout in front yard. 3921 Wabash Ave

Comments Front of building, 3921 Wabash Ave
